ANALYSIS AND RESEARCH OF THE CAUSES  
OF DAMAGE OF TECHNOLOGICAL DETAILS  
OF ENGINEERING PRODUCTS

Kamelia Kalchevska<sup>✉</sup>, Hristo Argirov

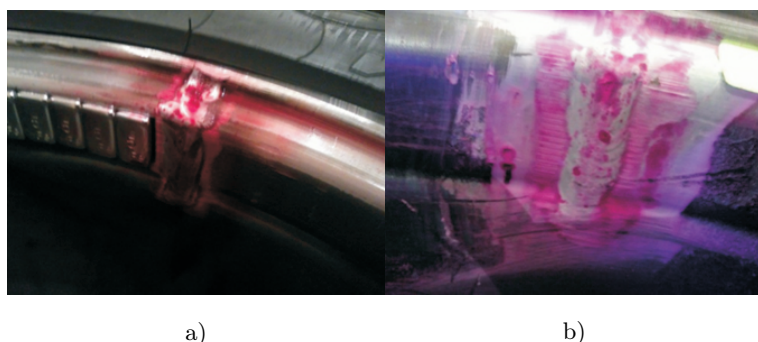
**Car rim.** The welding joints of the rim of a light truck were examined and analyzed by capillary non-destructive control penetrants. The resulting radiographs are presented in Fig. 1. As a result of control analysis with penetrating liquids, it was found that after repair (welding) of the rim of light truck, in the welding joints unacceptable by standards [5, 6] pores with a diameter of  $2 \pm 5$  mm are observed. As a result, poor quality welding joints lead to an emergency situation with the rim and hence the light truck. The resulting radiographs are presented in Fig. 1.

Fig. 1. PT control of welding joints a), and b)  $\times 5$

2) Welded joints of a light truck rim were investigated and analyzed by capillary non-destructive testing penetrants. As a result of a control analysis with penetrant liquids it was found that after repair (welding) of the rim of a light truck, in the welding joints, inadmissible pores with a diameter of  $2 \pm 5$  mm were observed. As a result, poor-quality welding joints lead to an emergency situation with the rim and therefore on the light truck.

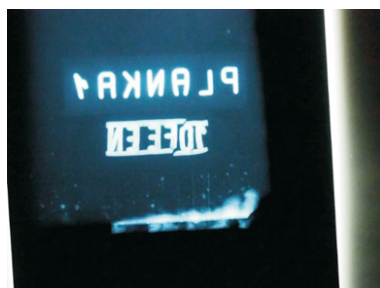
other rail. There are also no signs of friction on the roller cassette and the roller (wedge mechanism) which means that the same has not been activated. Figure 3 shows radiographs of weld joints from the box holding the ropes, obtained through non-destructive testing methods.

Fig. 3. Radiographs of welding joints
