## CONSTRUCTION FEATURES OF DRILLING TOOLS AND MACHINES IN MINING

Stoyan Velev<sup>✉</sup>, Kamelia Kalchevska

### Abstract

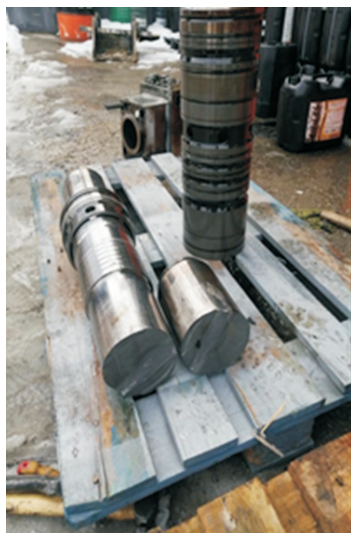
a. Broken piston

**Product. Metal materials and forging.** A test to clarify the reasons for breaking a hydraulic hammer workpiece plunger with No FURUKAWA.

Details of a geological exploration company – piston Fig. 2a, b position No. 8 in the structural documentation – from broken hydraulic hammer FURUKAWA.

The specimen is of steel type 40Ch2N2MA. DIN analogue 1.6565 40NiCrMo 6; Analogue: Japanese brand JAPAN JIS No. G 4103 steel grade SNCM8 type.

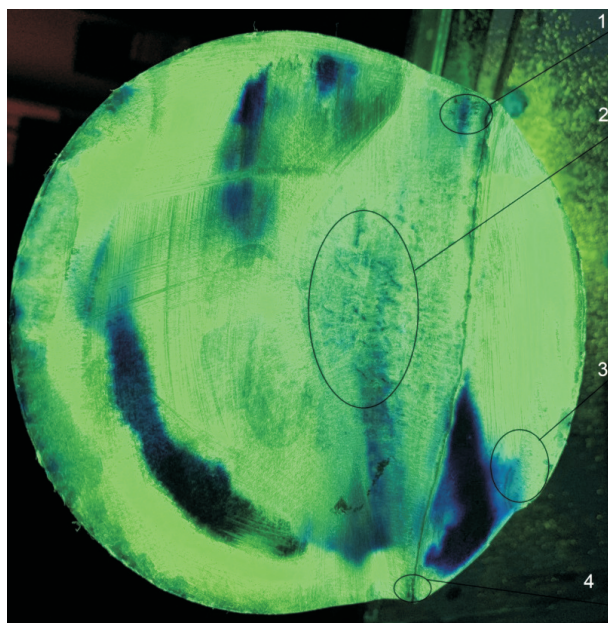
Fig. 3. Analysis with penetrating fluids of workpiece from Fig. 2a

- 1 – Cluster of pores in the fracture region and an incipient crack about 35 mm long;
- 2 – Cracks min 15 pieces with lengths between 1.5 and 12 mm;
- 3 – Single pores between 0.5 and 2 mm;
- 4 – Pores and a crack measuring about 9 mm.

tered cracks inside the forging, as well as pores (in blue) at the two diametrically opposite ends, clearly show the dividing line of destruction. The demolition area clearly indicates that the load is above the allowable. Unfortunately, the element was part of the equipment for climbers and shearing the stem of the bolt could cause compromising of climber equipment.
