## CONSTRUCTION FEATURES OF DRILLING TOOLS AND MACHINES IN MINING

Stoyan Velev<sup>✉</sup>, Kamelia Kalchevska

### Abstract

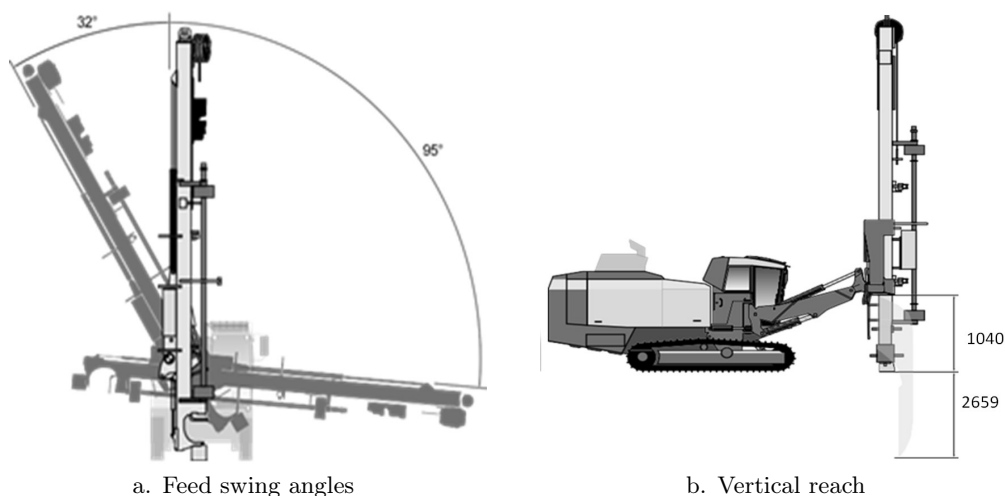
Fig. 1. Product FlexiROC D50

Based on this, data were tracked for a vertical drilling hammer type Hammer and a piston from a drilling machine brand FlexiROC D50 (Fig. 1).
